# UNDERWATER BRIDGE INSPECTION REPORT

STRUCTURE NO. 49520  
CSAH NO. 1  
OVER THE  
CROW WING RIVER  
DISTRICT 3 - MORRISON COUNTY

PREPARED FOR THE  
MINNESOTA DEPARTMENT OF TRANSPORTATION  
BY  
COLLINS ENGINEERS, INC.  
JOB NO. 5221 (CEI 65)

MINNESOTA DEPARTMENT OF TRANSPORTATION  
UNDERWATER BRIDGE INSPECTION

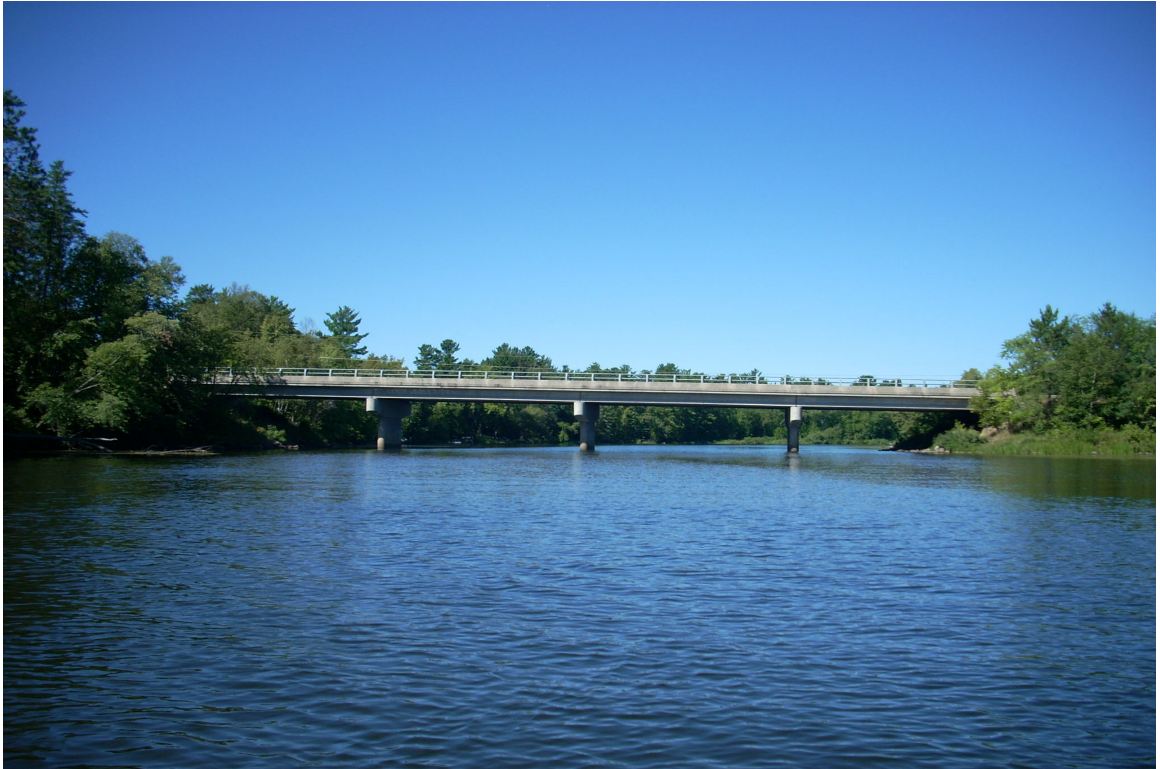
Photograph 1. Overall View of the Structure, Looking West.

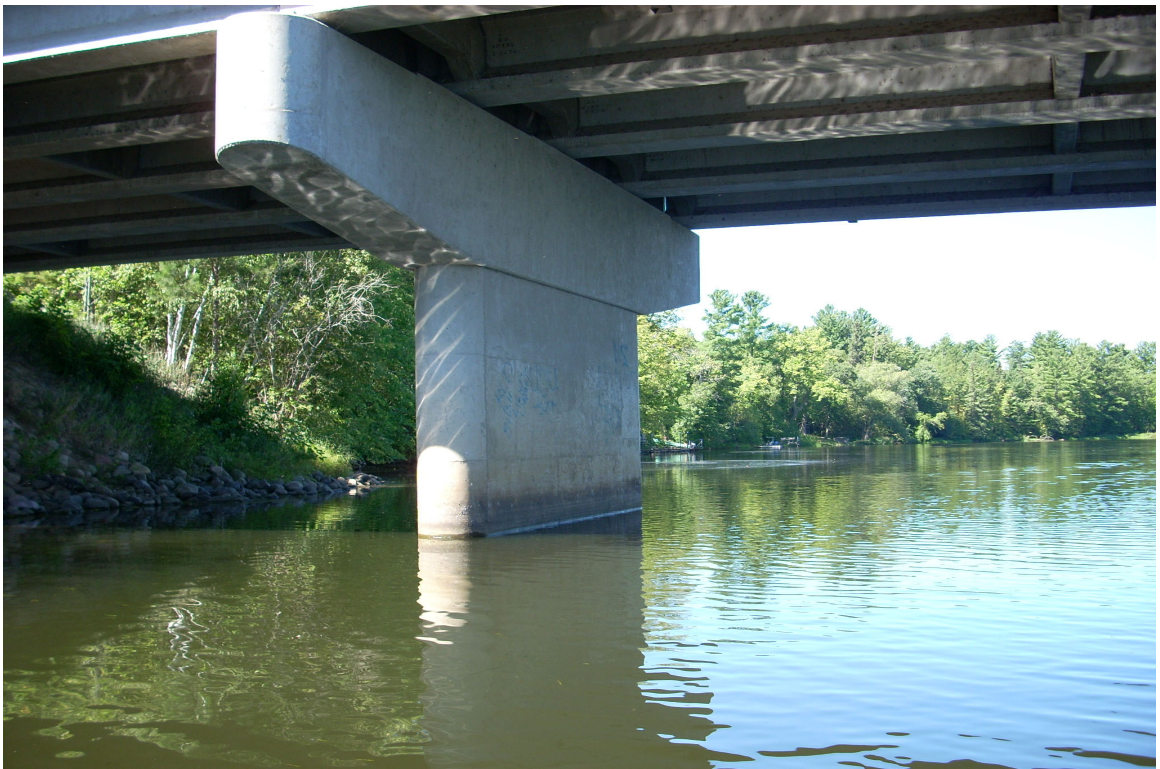
Photograph 2. View of Pier 1, Looking Southwest.

- 6 The footing was exposed from downstream 1/4 point to the upstream nose along the north face of Pier 1 with no vertical exposure.
- 7 A 3-foot-radius, 1.5-foot-deep scour pocket was observed at the upstream end of Pier 3.

- 8 A 4-foot-radius, 1-foot-deep scour pocket was observed at the upstream end of Piers 1 and 2.
- 9 The southwest corner of the exposed footing exhibited a 6-inch-diameter area of section loss with up to 1/2 inch of penetration.

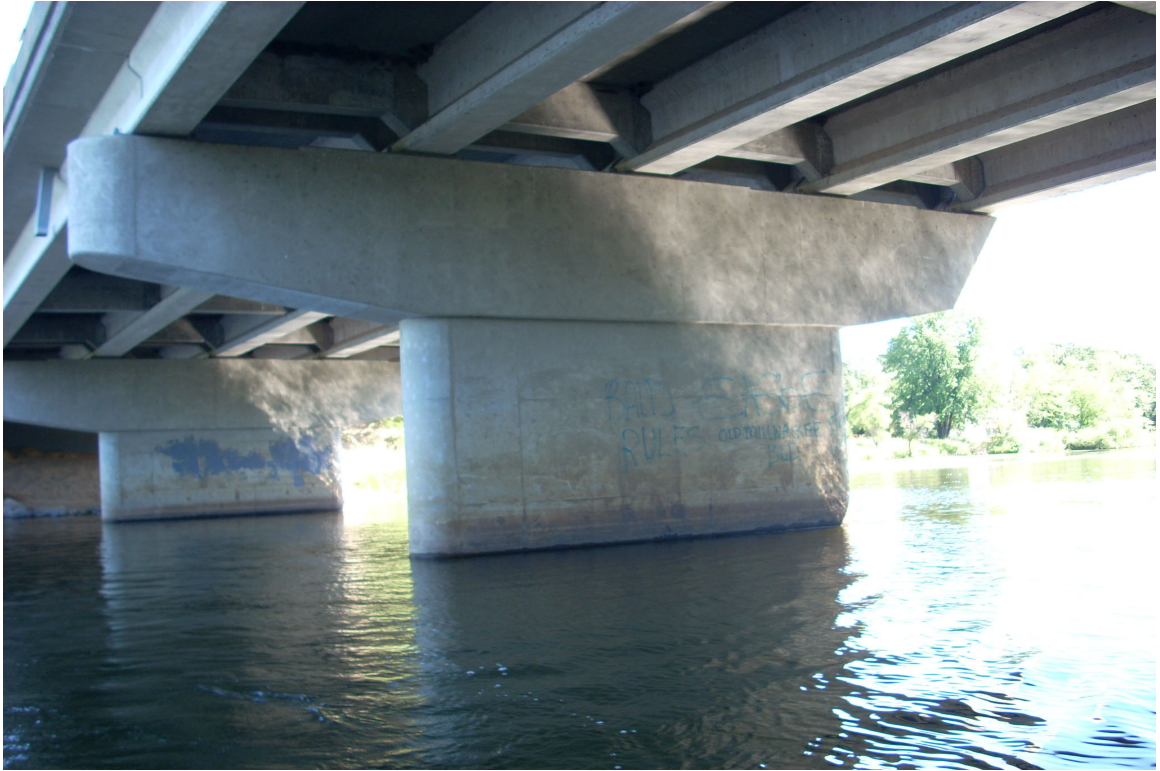
Photograph 3. View of Pier 2, Looking Northeast.

- 2 A moderate to heavy accumulation of 2-foot-diameter and smaller timber debris was observed at the upstream end of Pier 2, extending vertically 7 feet from the channel bottom, and extending up to 5 feet from the north face, 20 feet from the south face, and 15 feet west of the upstream end.

- 5 The footing was exposed along the entire west and east faces and at the upstream end of Pier 2 with up to 1 foot of vertical exposure at the upstream end.

Monitor the timber debris at Pier 2, and if found to be increasing in the future, removal operations may become warranted.

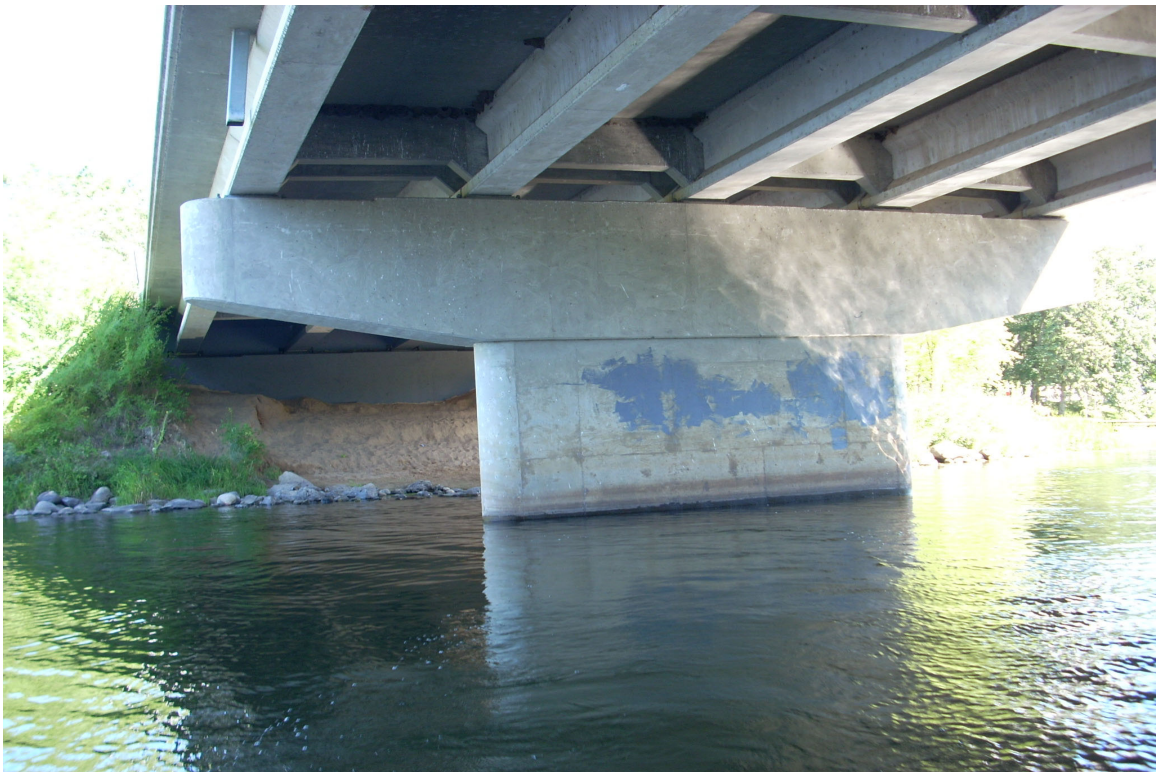
Photograph 4. View of Pier 3, Looking Northeast.
